# YOUR ONESURVEY HOME REPORT

11b Kings Place  
Perth  
PH2 8AA

# Structural Appraisal Report, 11B Kings Place, Perth, PH2 8AA

## Prepared for Black Hay , Ayr

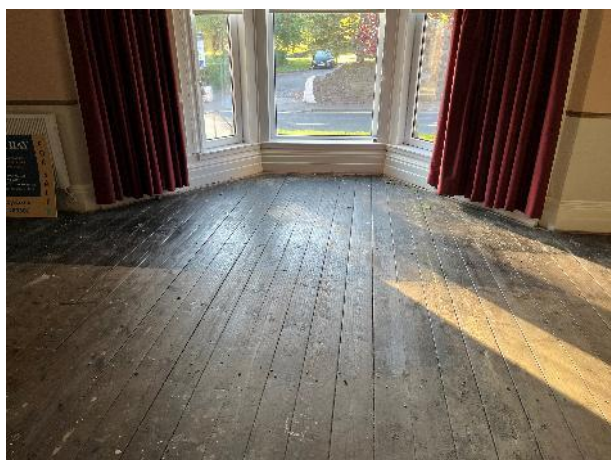
Front bay window – internal

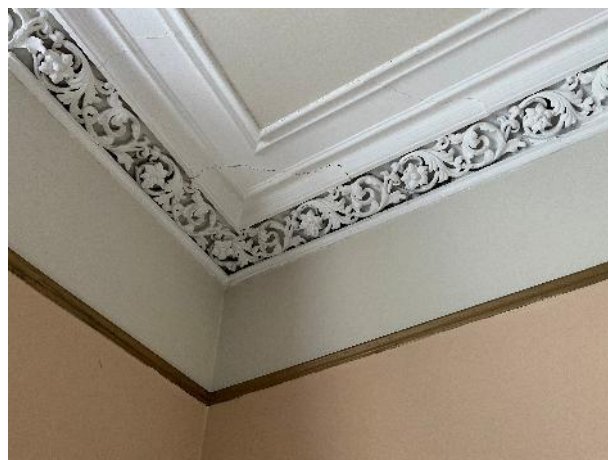
Crack in cornice within lounge

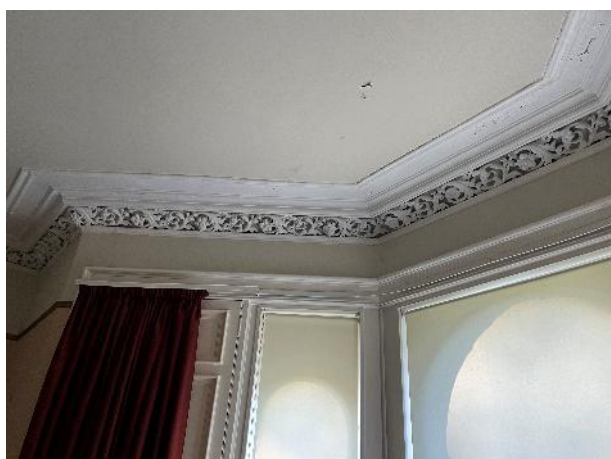
Cornice to bay window

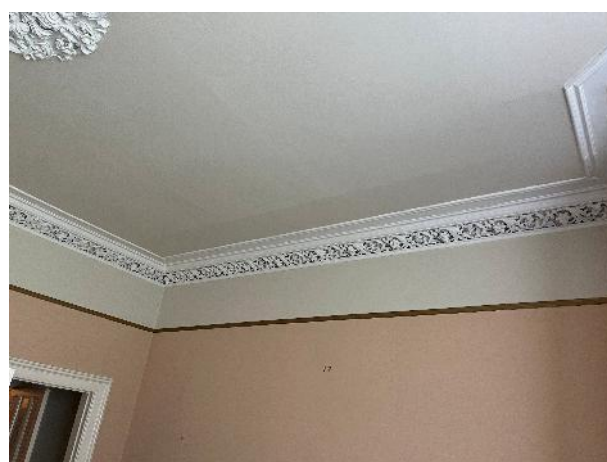
Uneven ceiling (lounge)

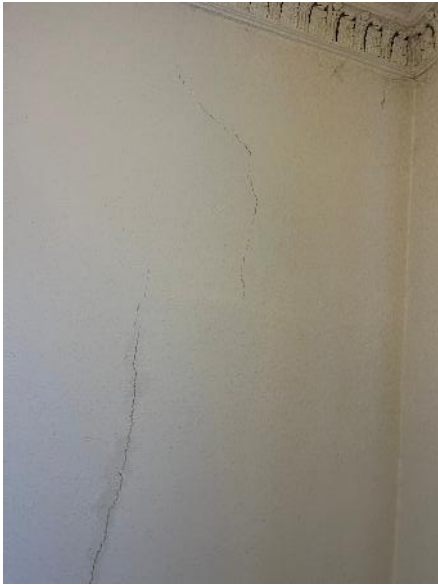
Crack in bedroom wall (gable)

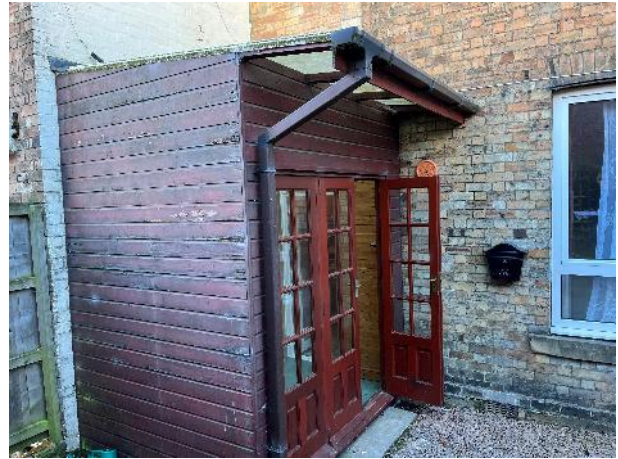
| Notes: | The timber porch to the rear of the property is of a basic construction type only. Timber decay is evident. Future repairs will be necessary. |

Rear timber porch

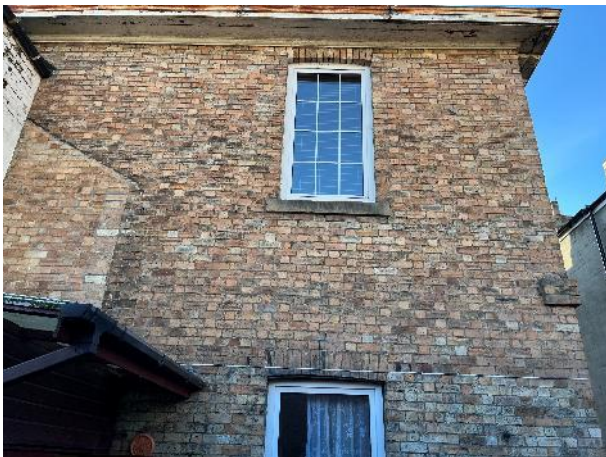
Minor crack above bedroom window

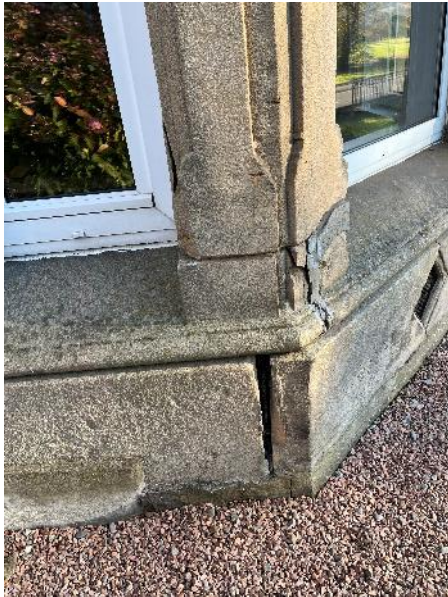
Movement in bay window and historic repair
