YOUR ONESURVEY  
**HOME REPORT**

2 Merkland Road  
Ayr  
KA7 4UQ

# Structural Appraisal Report, 2 Merkland Road, Alloway.

## Prepared for the Estate of Miss Mary Davey, C/O Black Hay Solicitors

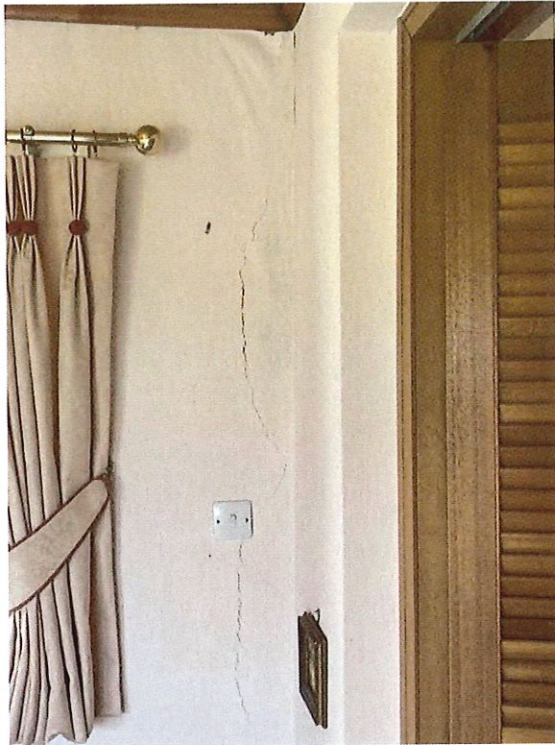
Extension – cracks in right hand east return wall

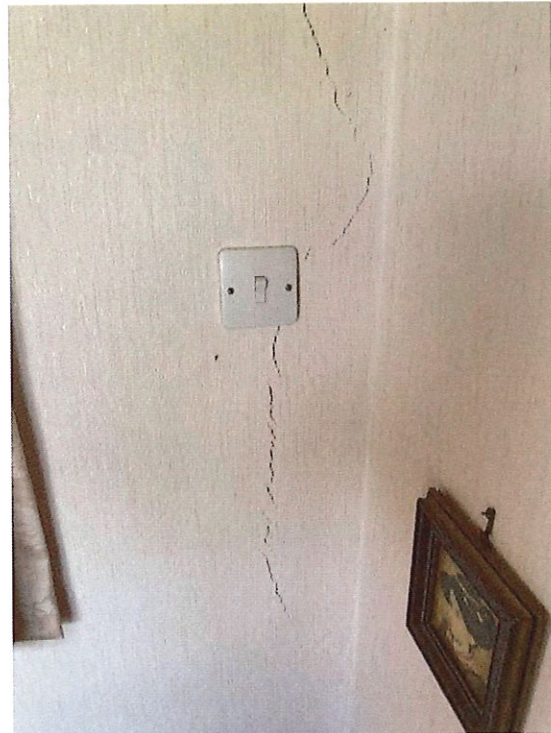
Extension – cracks in right hand east return wall – close up

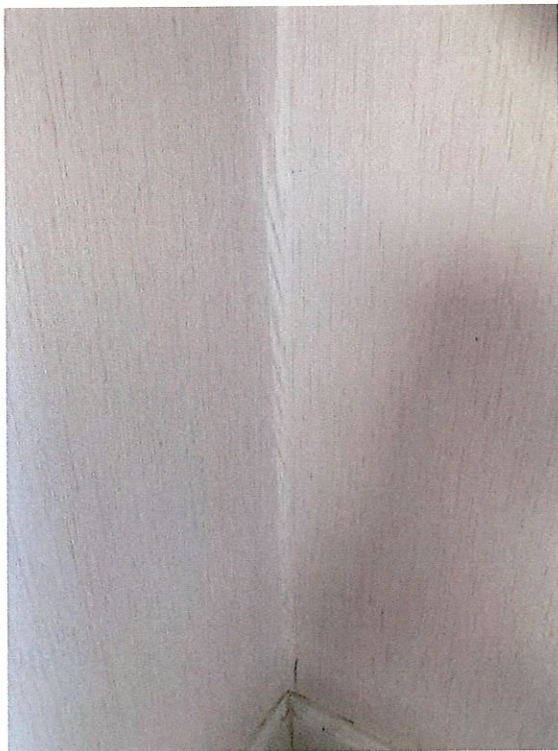
Extension – left hand west return wall rippling wallpaper

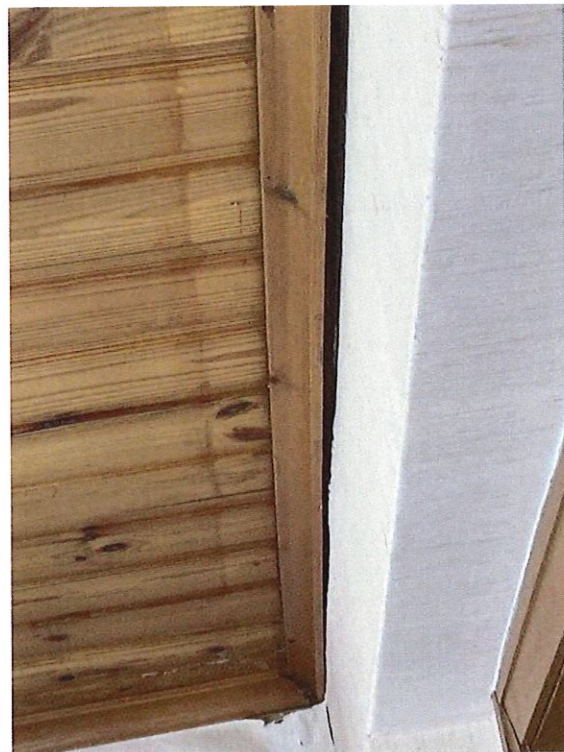
Extension – timber ceiling – gap at join with main house

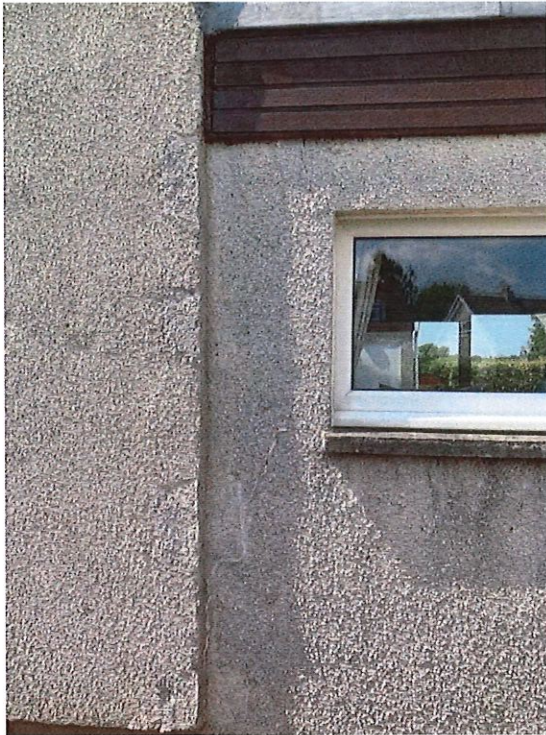
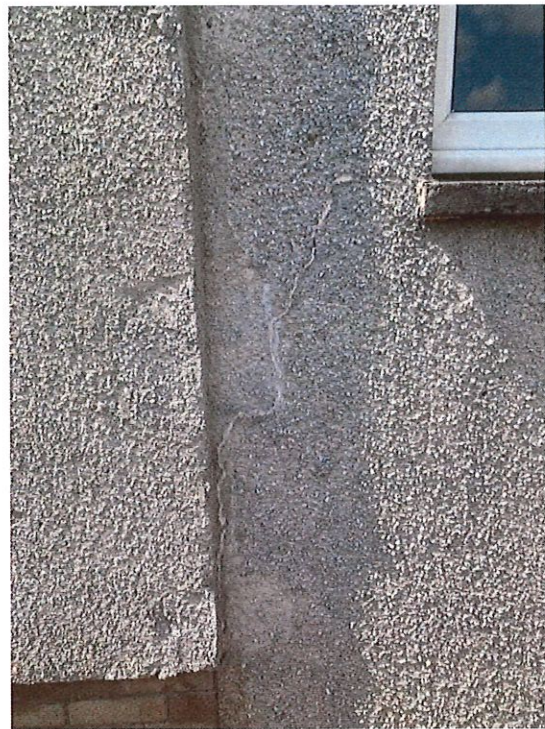
External – east extension wall – cracks in render  
Infilled with sealant.

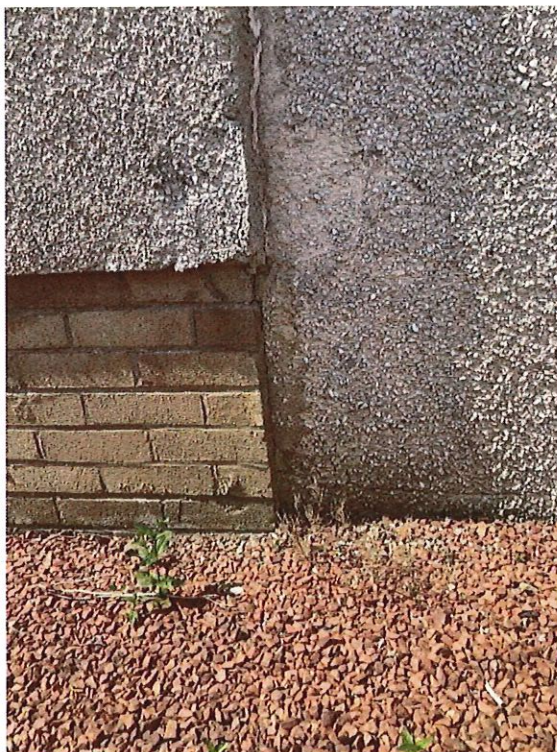
External -east extension wall – low level crack

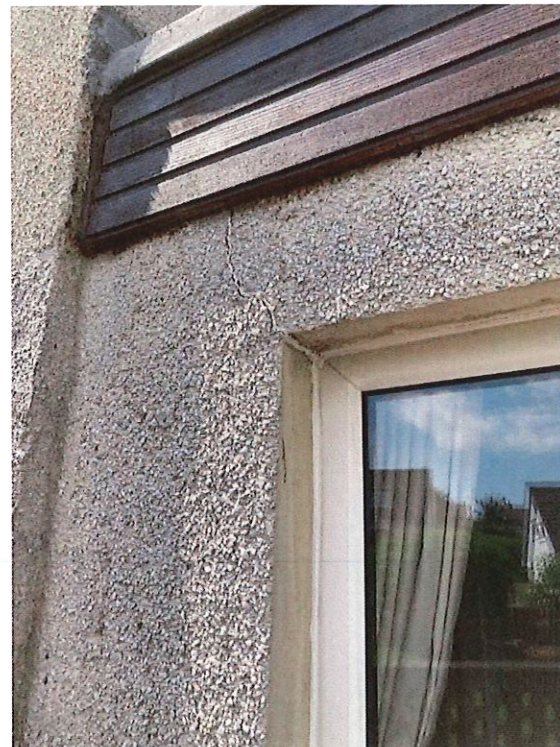
External -east extension wall – high level diagonal  
crack

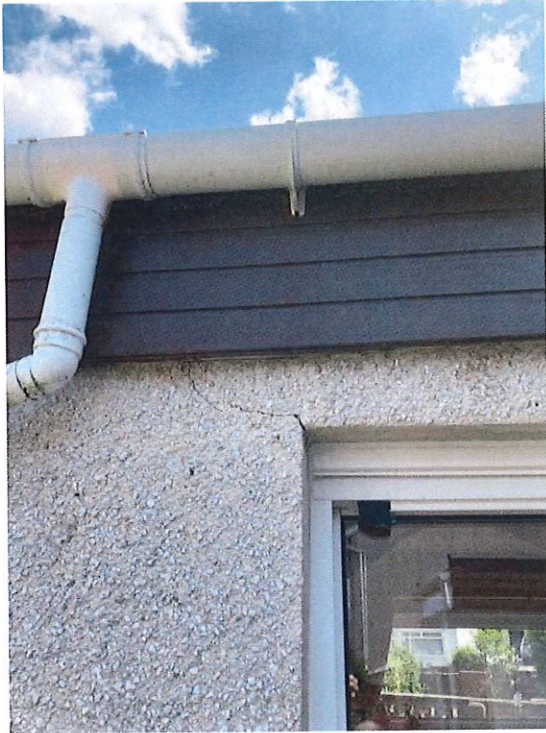
External -west extension wall – high level crack

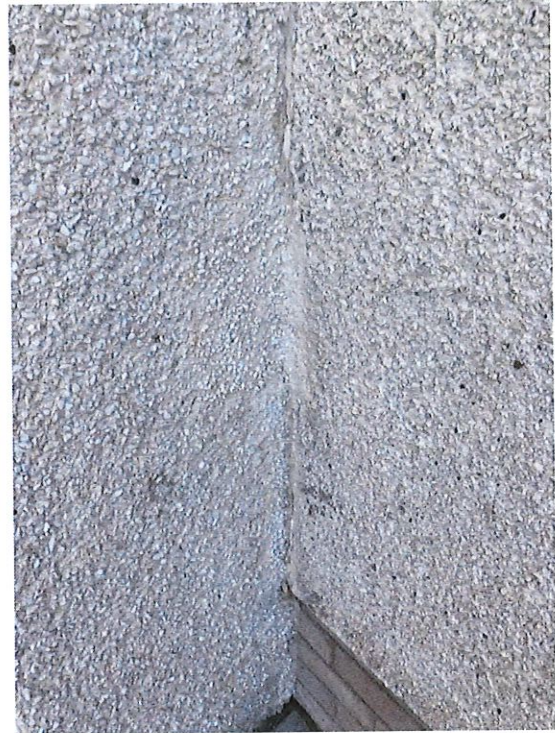
External -west extension wall – flexible sealant at wall join

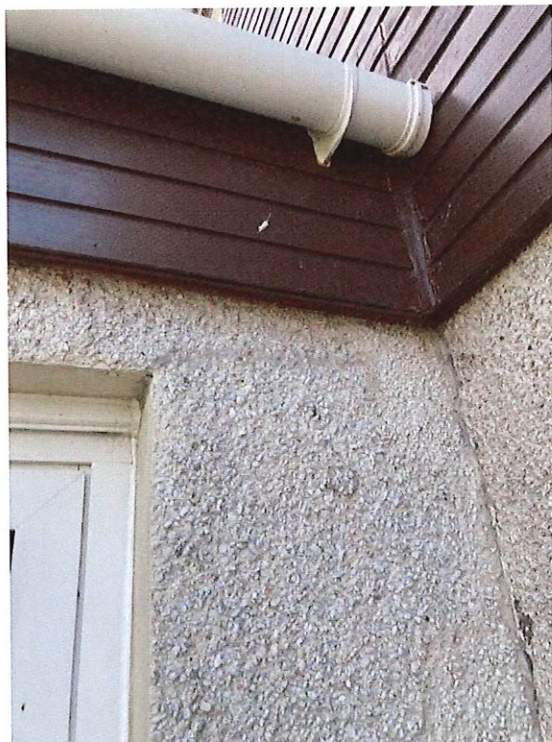
External -west extension wall – high level crack

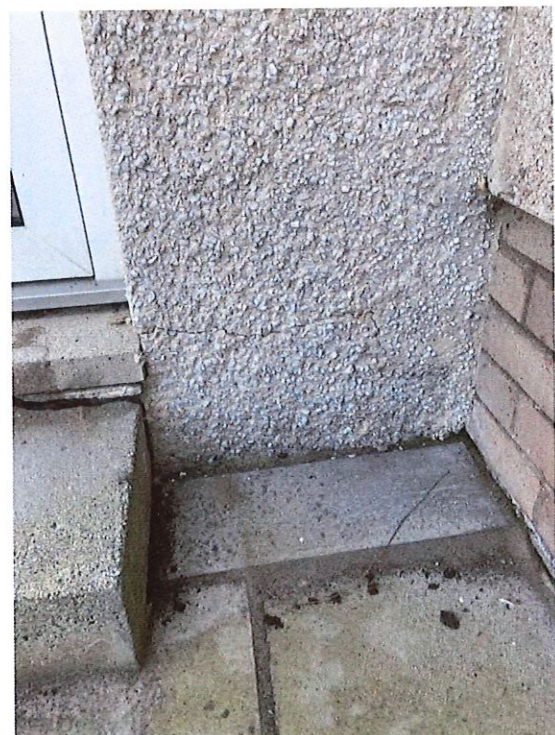
External -west extension wall – low level crack

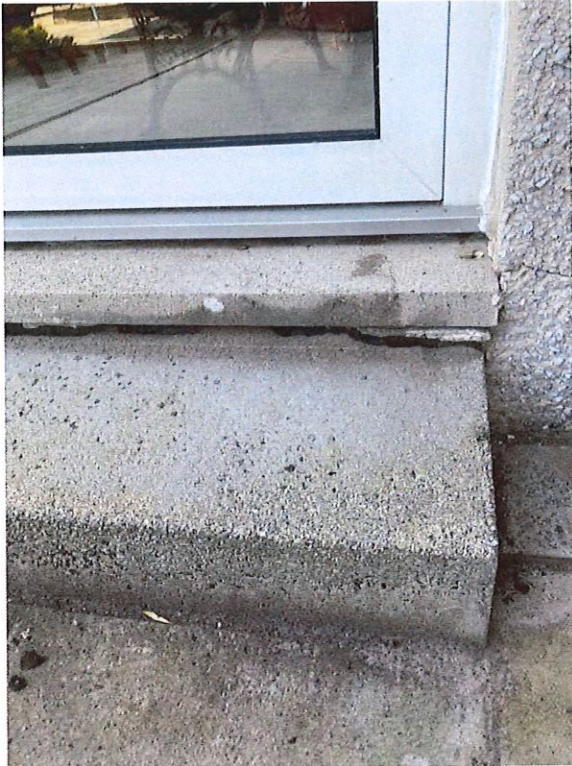
External -west extension wall – step has settled away  
From threshold.
