# YOUR ONESURVEY HOME REPORT

4 Ryelands Prestwick KA9 2DX

# SINGLE SURVEY

Surveyor Reference	AD/6019
Customer	Clients of Black Hay
Customer address	4 Ryelands Prestwick KA9 2DX
Date of Inspection	22/10/2018
Prepared by	Kevin S Hay, BSc MRICS Ayr - Allied Surveyors Scotland Plc

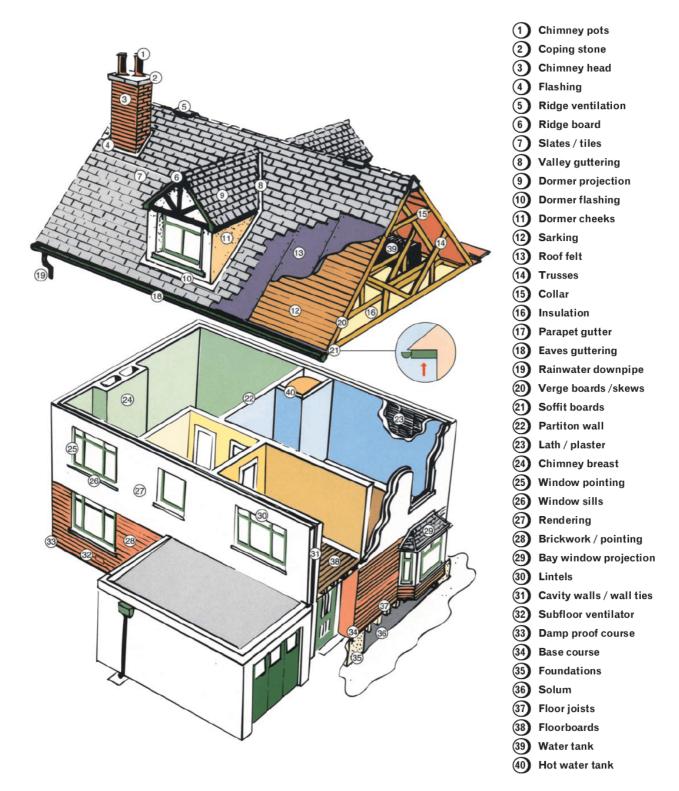
# Sectional Diagram showing elements of a typical house

Reference may be made in this report to some or all of the above component parts of the property. This diagram may assist you in locating and understanding these items.
