# YOUR ONESURVEY HOME REPORT

21j Links Road Prestwick KA9 1QG

# SINGLE Survey

# Single Survey

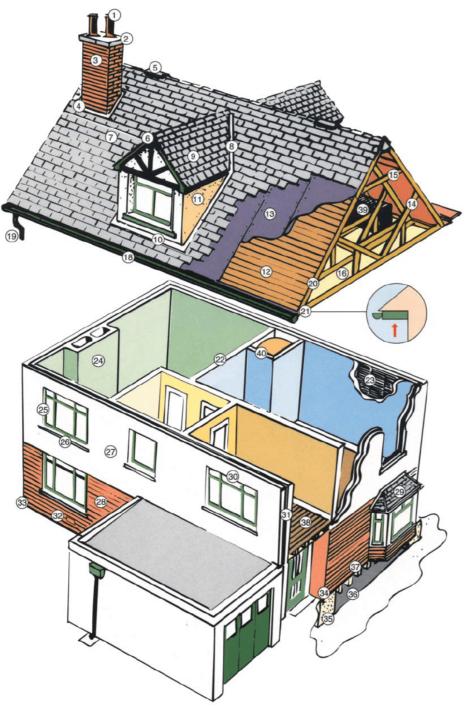
### Sectional Diagram showing elements of a typical house

Reference may be made in this report to some or all of the above component parts of the property. This diagram may assist you in locating and understanding these items.

1	Chimney pots
	2	Coping stone
	3	Chimney head
	4	Flashing
	5	Ridge ventilation
	6	Ridge board
	1	Slates / tiles
	8	Valley guttering
	9	Dormer projection
	10	Dormer flashing
	<b>11</b>	Dormer cheeks
	12	Sarking
•	13	Roof felt
	14	Trusses
	15	Collar
	16	Insulation
	17	Parapet gutter
	18	Eaves guttering
	<b>(19)</b>	Rainwater downpipe
	20	Verge boards/skews
	21	Soffit boards
	22	Partiton wall
	23	Lath / plaster
	24	Chimney breast
	25	Window pointing
	26	Window sills
	27	Rendering
	28	Brickwork / pointing
	29	Bay window projection
	30	Lintels
	31	Cavity walls / wall ties
	32	Subfloor ventilator
	33	Damp proof course
	34	Base course
	35	Foundations
	36	Solum
	37	Floor joists
	38	Floorboards
	39	Water tank
	<b>40</b>	Hot water tank
	-

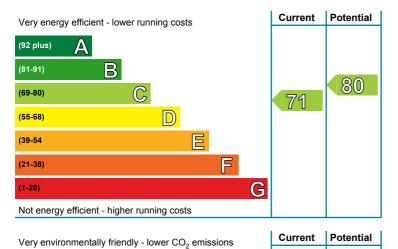
#### **Energy Efficiency Rating**

This graph shows the current efficiency of your home, taking into account both energy efficiency and fuel costs. The higher this rating, the lower your fuel bills are likely to be.
