# YOUR ONESURVEY HOME REPORT

2 Abercromby Drive Ayr KA7 4DQ

# SINGLE SURVEY

# Single Survey

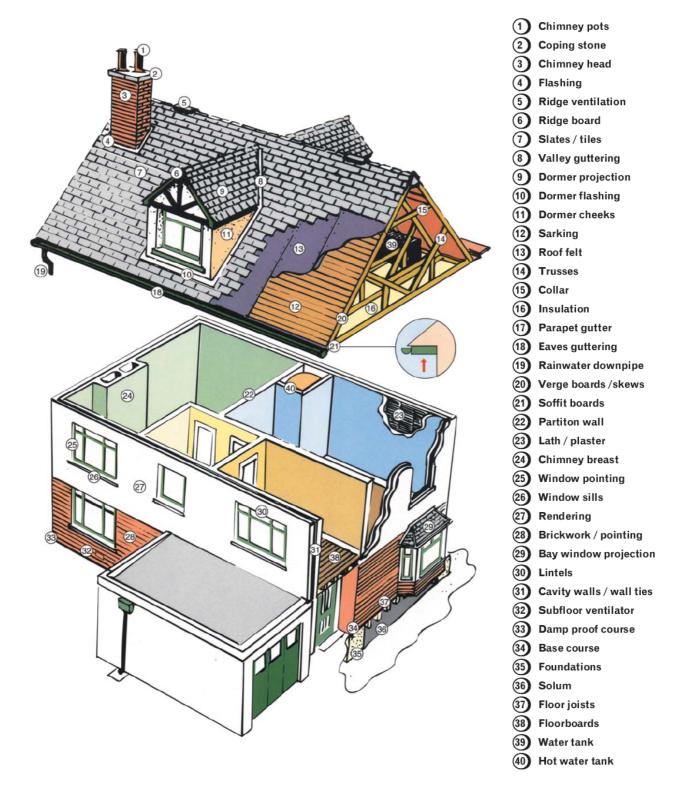
# Sectional Diagram showing elements of a typical house

Reference may be made in this report to some or all of the above component parts of the property. This diagram may assist you in locating and understanding these items.
