HOME REPORT

Schoolhouse, 8 Brewlands Road
Symington, Kilmarnock
KA1 5QX

home report index

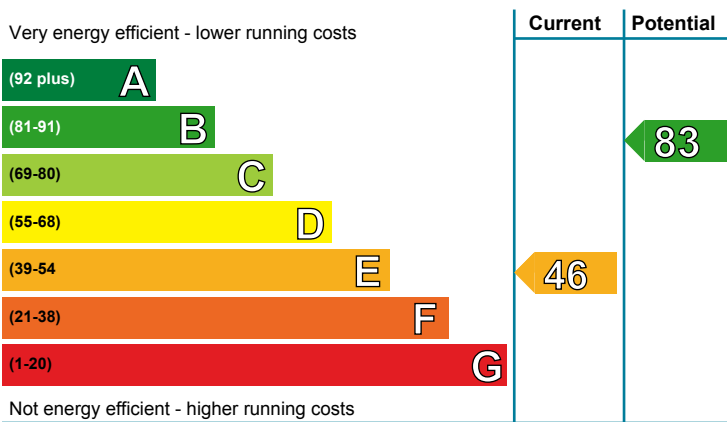
Energy Efficiency Rating

This graph shows the current efficiency of your home, taking into account both energy efficiency and fuel costs. The higher this rating, the lower your fuel bills are likely to be.

Your current rating is **band E (46)**. The average rating for EPCs in Scotland is **band D (61)**.

The potential rating shows the effect of undertaking all of the improvement measures listed within your recommendations report.

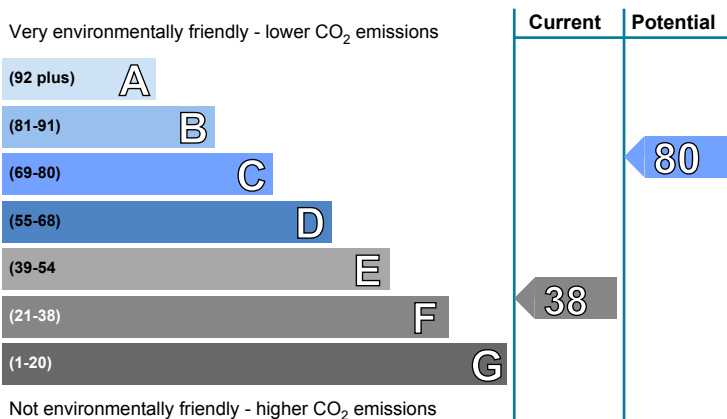
Environmental Impact (CO₂) Rating

This graph shows the effect of your home on the environment in terms of carbon dioxide (CO₂) emissions. The higher the rating, the less impact it has on the environment.
