YOUR ONESURVEY  
**HOME REPORT**

3 Westbourne Gardens  
Prestwick  
KA9 1JE

# SINGLE SURVEY

A report on the condition of the property, with categories being rated from 1 to 3.

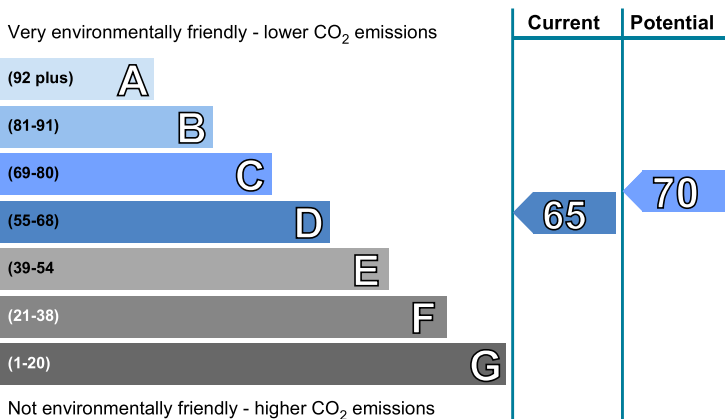
## Environmental Impact (CO<sub>2</sub>) Rating

This graph shows the effect of your home on the environment in terms of carbon dioxide (CO<sub>2</sub>) emissions. The higher the rating, the less impact it has on the environment.
