YOUR ONESURVEY
HOME REPORT

28 Marchburn Avenue
Prestwick
KA9 1DA

SINGLE SURVEY

A report on the condition of the property, with categories being rated from 1 to 3.

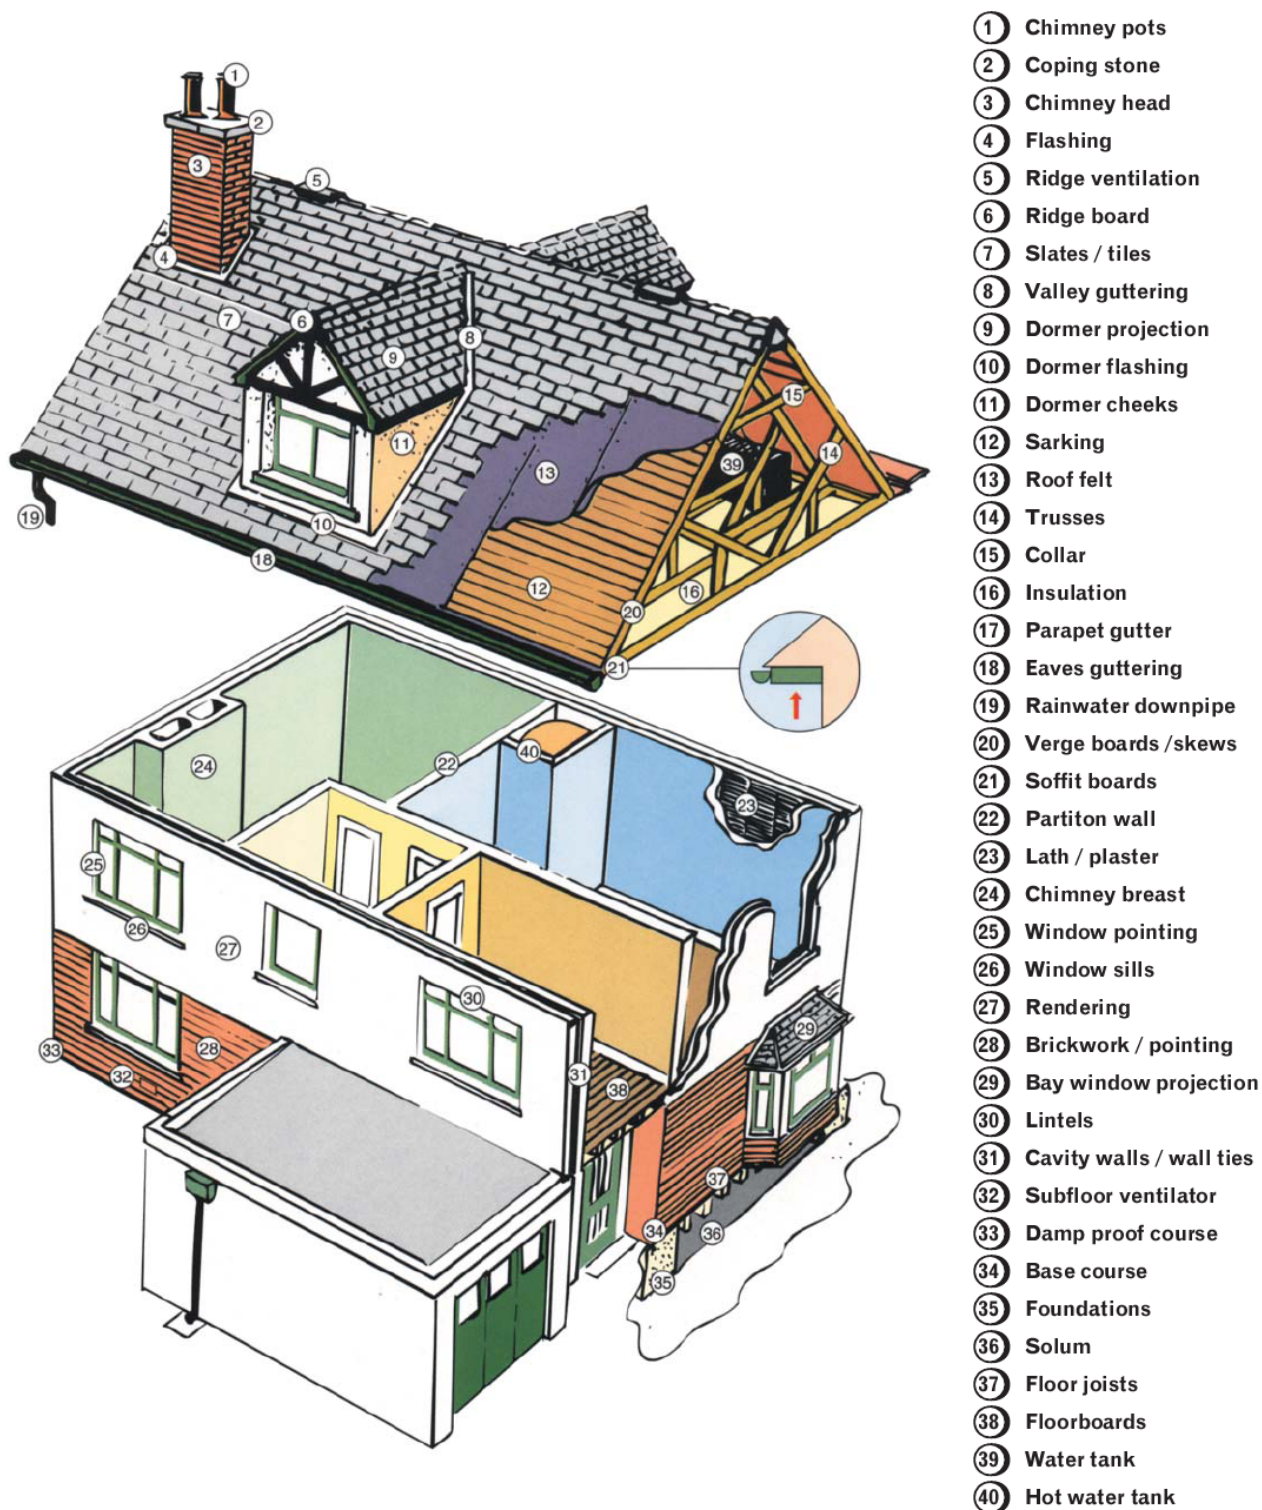
Sectional Diagram showing elements of a typical house

- ① Chimney pots
- ② Coping stone
- ③ Chimney head
- ④ Flashing
- ⑤ Ridge ventilation
- ⑥ Ridge board
- ⑦ Slates / tiles
- ⑧ Valley guttering
- ⑨ Dormer projection
- ⑩ Dormer flashing
- ⑪ Dormer cheeks
- ⑫ Sarking
- ⑬ Roof felt
- ⑭ Trusses
- ⑮ Collar
- ⑯ Insulation
- ⑰ Parapet gutter
- ⑱ Eaves guttering
- ⑲ Rainwater downpipe
- ⑳ Verge boards /skews
- ㉑ Soffit boards
- ㉒ Partiton wall
- ㉓ Lath / plaster
- ㉔ Chimney breast
- ㉕ Window pointing
- ㉖ Window sills
- ㉗ Rendering
- ㉘ Brickwork / pointing
- ㉙ Bay window projection
- ㉚ Lintels
- ㉛ Cavity walls / wall ties
- ㉜ Subfloor ventilator
- ㉝ Damp proof course
- ㉞ Base course
- ㉟ Foundations
- ㊱ Solum
- ㊲ Floor joists
- ㊳ Floorboards
- ㊴ Water tank
- ㊵ Hot water tank

Reference may be made in this report to some or all of the above component parts of the property. This diagram may assist you in locating and understanding these items.
