YOUR ONESURVEY HOME REPORT

1d Beresford Mews Ayr KA7 2DW

Single Survey

MORTGAGE VALUATION REPORT

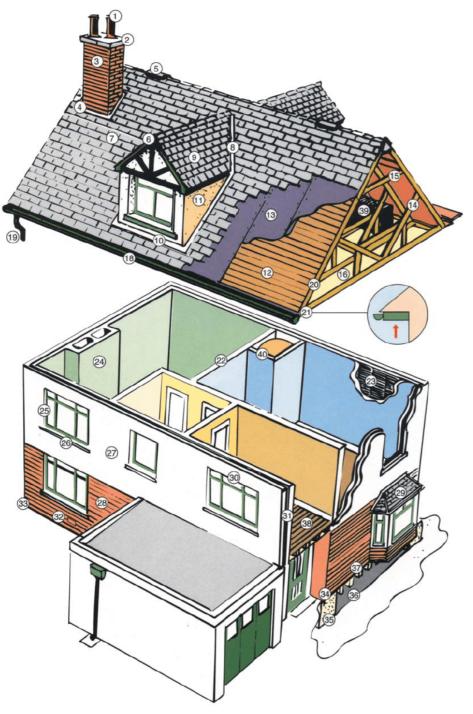
Sectional Diagram showing elements of a typical house

Reference may be made in this report to some or all of the above component parts of the property. This diagram may assist you in locating and understanding these items.

1	Chimney pots
2	Coping stone
3	Chimney head
4	Flashing
5	Ridge ventilation
6	Ridge board
\bigcirc	Slates / tiles
8	Valley guttering
9	Dormer projection
10	Dormer flashing
11	Dormer cheeks
12	Sarking
13	Roof felt
14	Trusses
15	Collar
16	Insulation
17	Parapet gutter
18	Eaves guttering
19	Rainwater downpipe
20	Verge boards /skews
21	Soffit boards
22	Partiton wall
23	Lath / plaster
24	Chimney breast
25	Window pointing
26	Window sills
27	Rendering
28	Brickwork / pointing
29	Bay window projection
30	Lintels
31	Cavity walls / wall ties
32	Subfloor ventilator
33	Damp proof course
34	Base course
35	Foundations
36	Solum
37	Floor joists
38	Floorboards
39	Water tank
40	Hot water tank
