YOUR ONESURVEY
HOME REPORT

6 Englewood Avenue
Ayr
KA8 9EF

SINGLE SURVEY

Single Survey

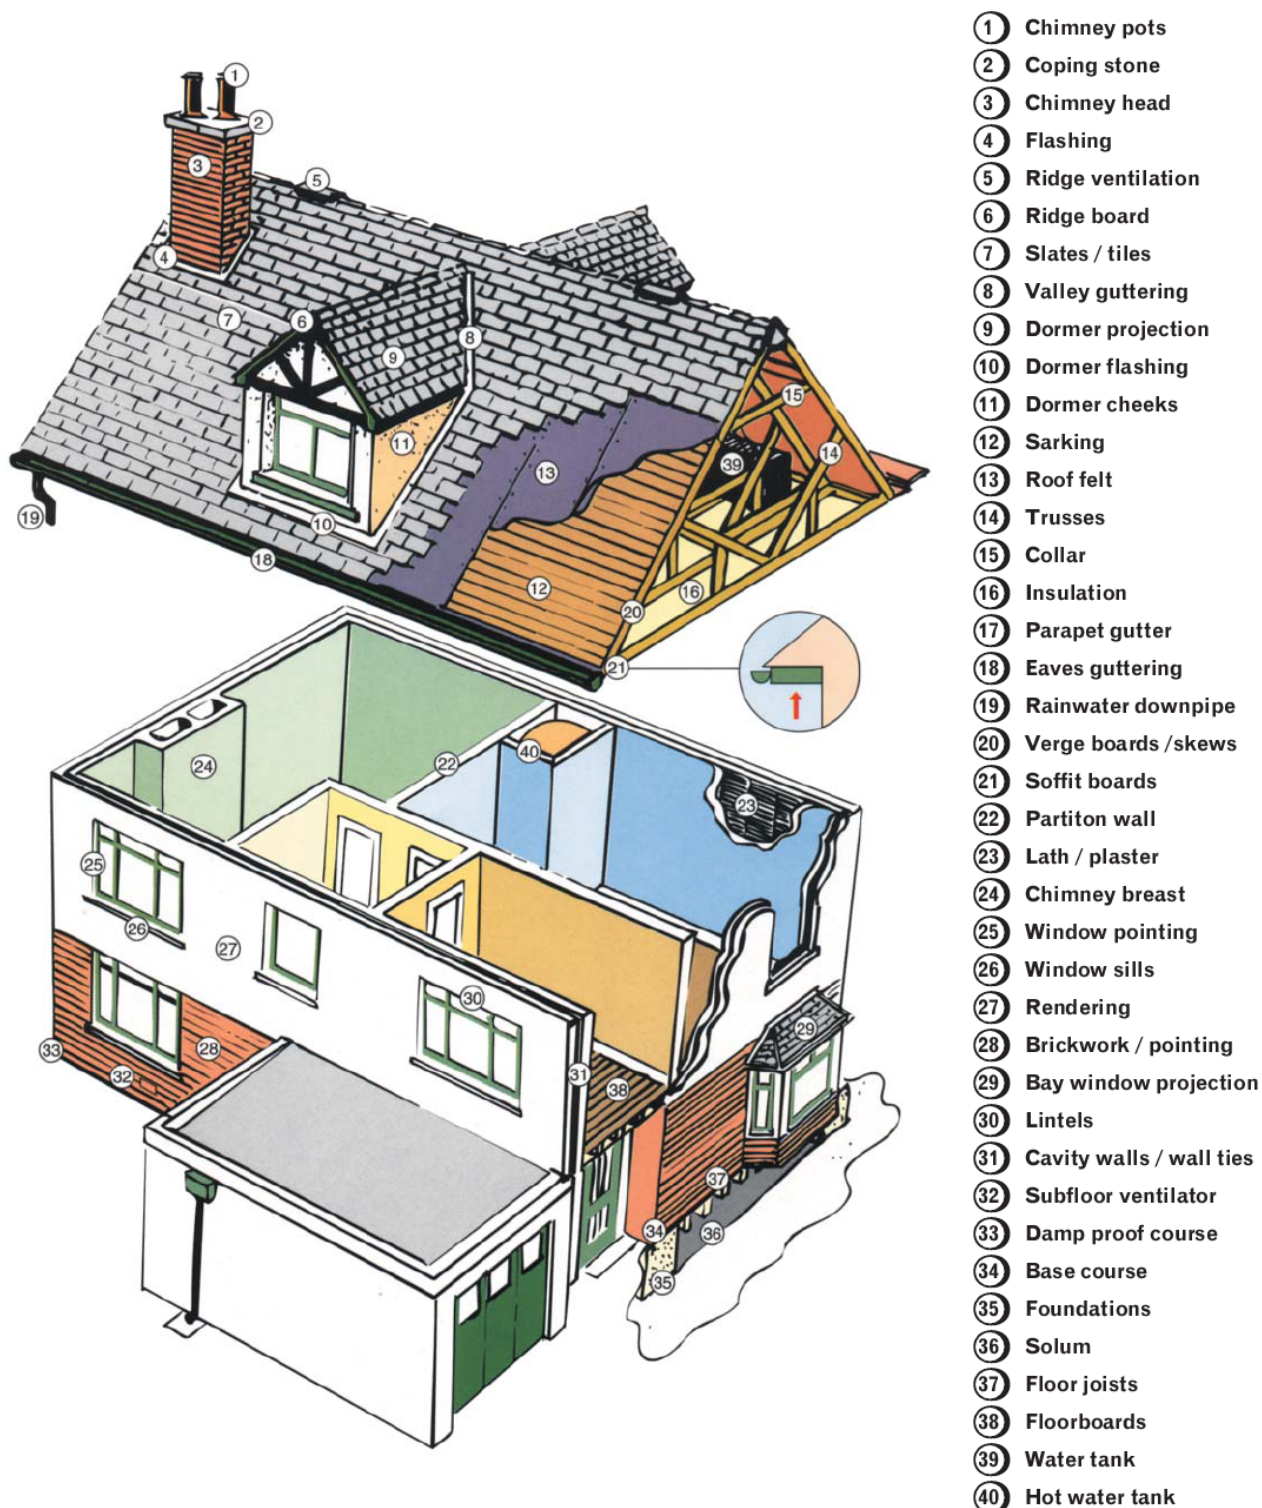
Sectional Diagram showing elements of a typical house

Reference may be made in this report to some or all of the above component parts of the property. This diagram may assist you in locating and understanding these items.
