YOUR ONESURVEY HOME REPORT

184 Adamton Road South
Prestwick
KA9 2AQ

SINGLE SURVEY

ENERGY REPORT

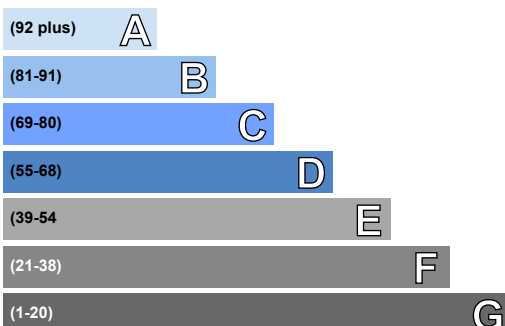
Environmental Impact (CO₂) Rating

Very environmentally friendly - lower CO₂ emissions

Current	Potential
65	79
