YOUR ONESURVEY  
**HOME REPORT**

6 Saunterne Road  
Prestwick  
KA9 2JQ

# SINGLE SURVEY

A report on the condition of the property, with categories  
being rated from 1 to 3.

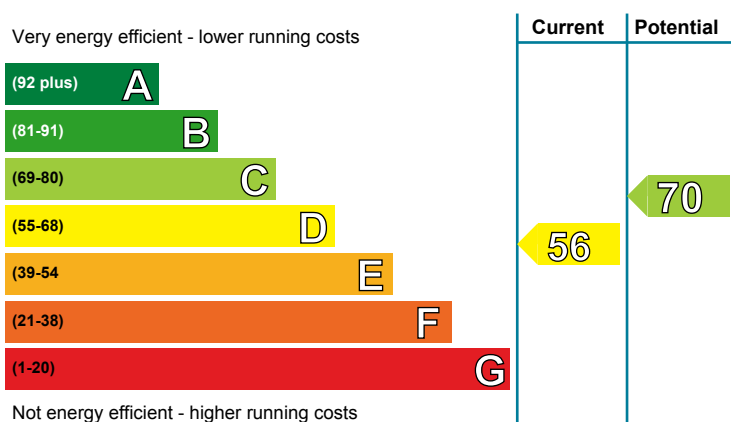
## Energy Efficiency Rating

This graph shows the current efficiency of your home, taking into account both energy efficiency and fuel costs. The higher this rating, the lower your fuel bills are likely to be.

Your current rating is **band D (56)**. The average rating for EPCs in Scotland is **band D (61)**.

The potential rating shows the effect of undertaking all of the improvement measures listed within your recommendations report.

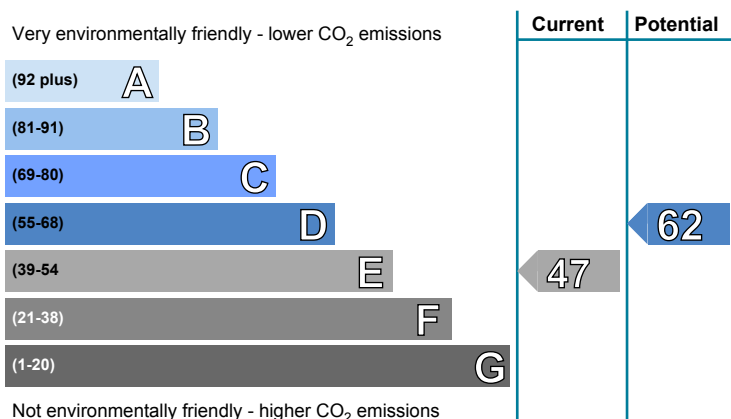
## Environmental Impact (CO<sub>2</sub>) Rating

This graph shows the effect of your home on the environment in terms of carbon dioxide (CO<sub>2</sub>) emissions. The higher the rating, the less impact it has on the environment.
