# YOUR ONESURVEY HOME REPORT

Flat F
3 Monkton Court
Prestwick
KA9 1EN

# SINGLE SURVEY

Surveyor Reference	YR240279
Customer	Client of Black Hay
Selling address	Flat F 3 Monkton Court Prestwick KA9 1EN
Date of Inspection	14/03/2024
Prepared by	Mark Rutherford, MA (hons) MRICS D M Hall - Ayr

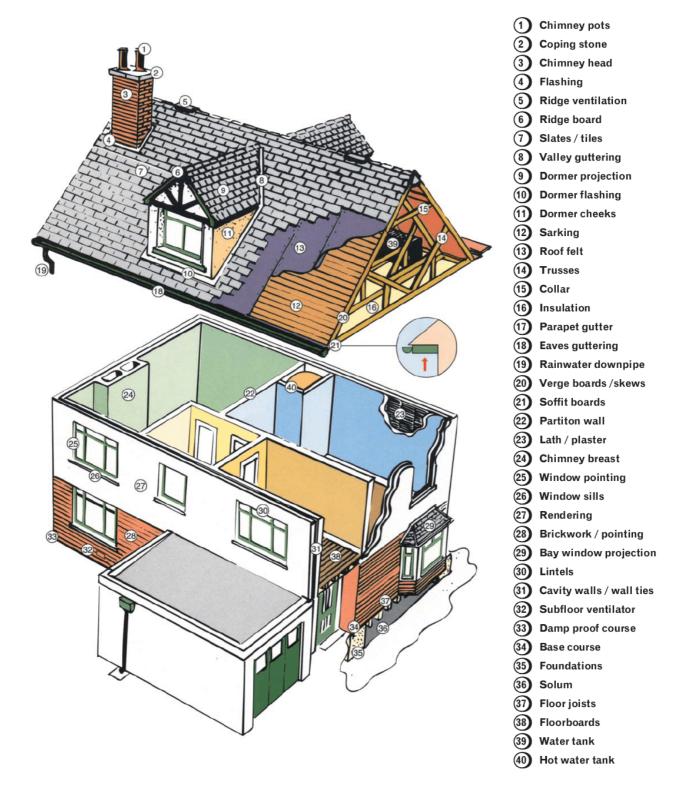
#### Sectional Diagram showing elements of a typical house

Reference may be made in this report to some or all of the above component parts of the property. This diagram may assist you in locating and understanding these items.
