# YOUR ONESURVEY HOME REPORT

18 Mount Avenue Symington, Kilmarnock KA1 5RU

# SINGLE SURVEY

# Single Survey

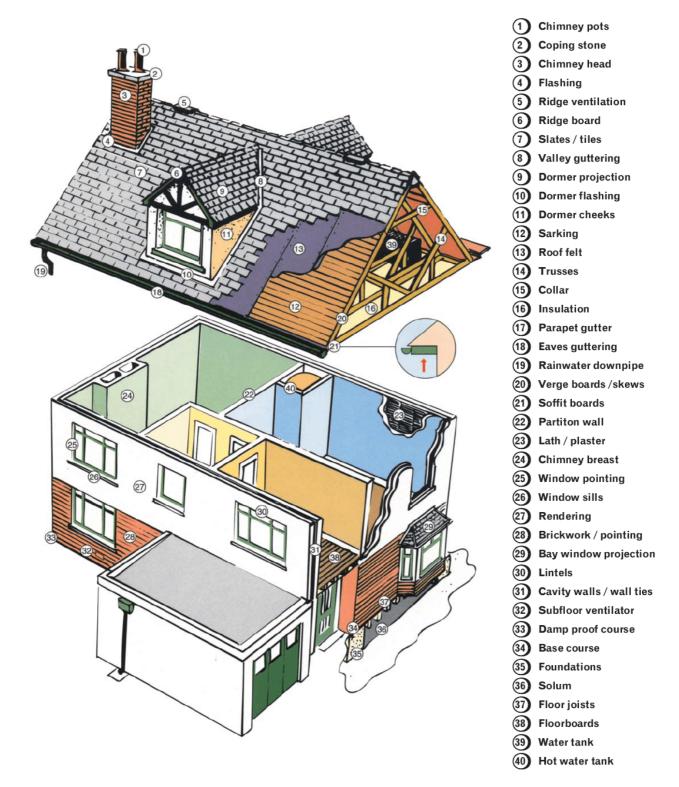
#### Sectional Diagram showing elements of a typical house

Reference may be made in this report to some or all of the above component parts of the property. This diagram may assist you in locating and understanding these items.
