YOUR ONESURVEY HOME REPORT

14 Macadam Square Ayr KA8 0DA

Single Survey

Surveyor Reference	YR230601
Customer	Client of Black Hay
Selling address	14 Macadam Square Ayr KA8 0DA
Date of Inspection	26/06/2023
Prepared by	Mark Rutherford, MA (hons) MRICS D M Hall - Ayr

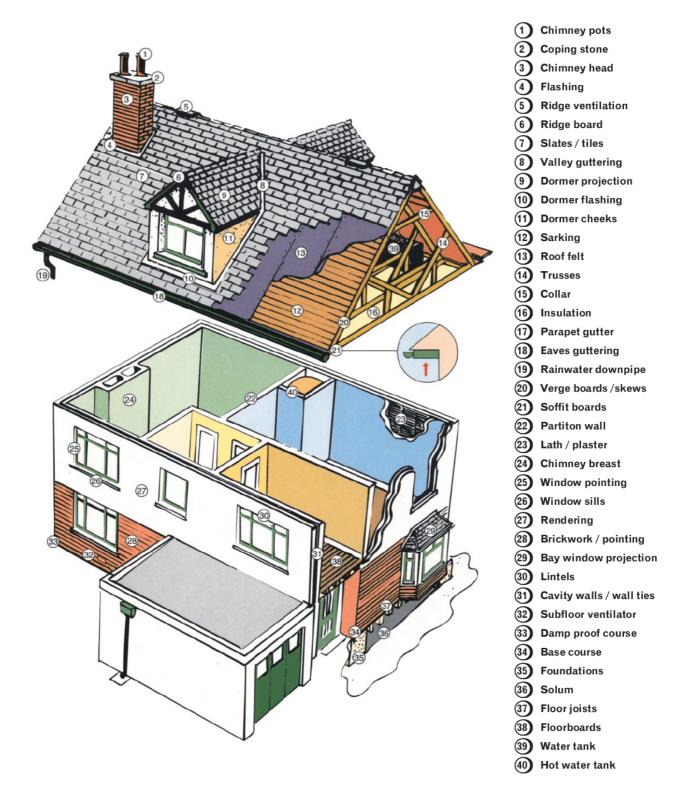
Sectional Diagram showing elements of a typical house

Reference may be made in this report to some or all of the above component parts of the property. This diagram may assist you in locating and understanding these items.
