YOUR ONESURVEY
HOME REPORT

21 Tweed Street
Ayr
KA8 9JD

SINGLE SURVEY

Single Survey

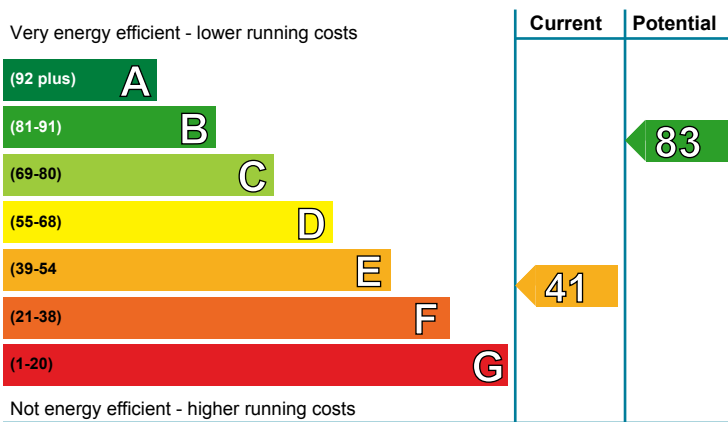
Energy Efficiency Rating

This graph shows the current efficiency of your home, taking into account both energy efficiency and fuel costs. The higher this rating, the lower your fuel bills are likely to be.

Your current rating is **band E (41)**. The average rating for EPCs in Scotland is **band D (61)**.

The potential rating shows the effect of undertaking all of the improvement measures listed within your recommendations report.

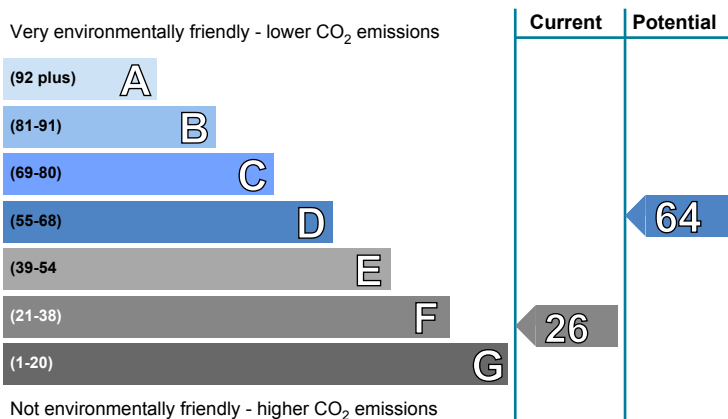
Environmental Impact (CO₂) Rating

This graph shows the effect of your home on the environment in terms of carbon dioxide (CO₂) emissions. The higher the rating, the less impact it has on the environment.
